Number 031

Address	Kaora Street, Kawhia
Tree Name	Norfolk Island pine (<i>Araucaria heterophylla</i>)
ID number	031
Dimensions (HxGxSpread)	Largest tree 32 x 2.75 x16

Location of Tree(s) on Site	Kaora Foreshore
Owners' Name	ODC
Date of Inspection	6 November 08

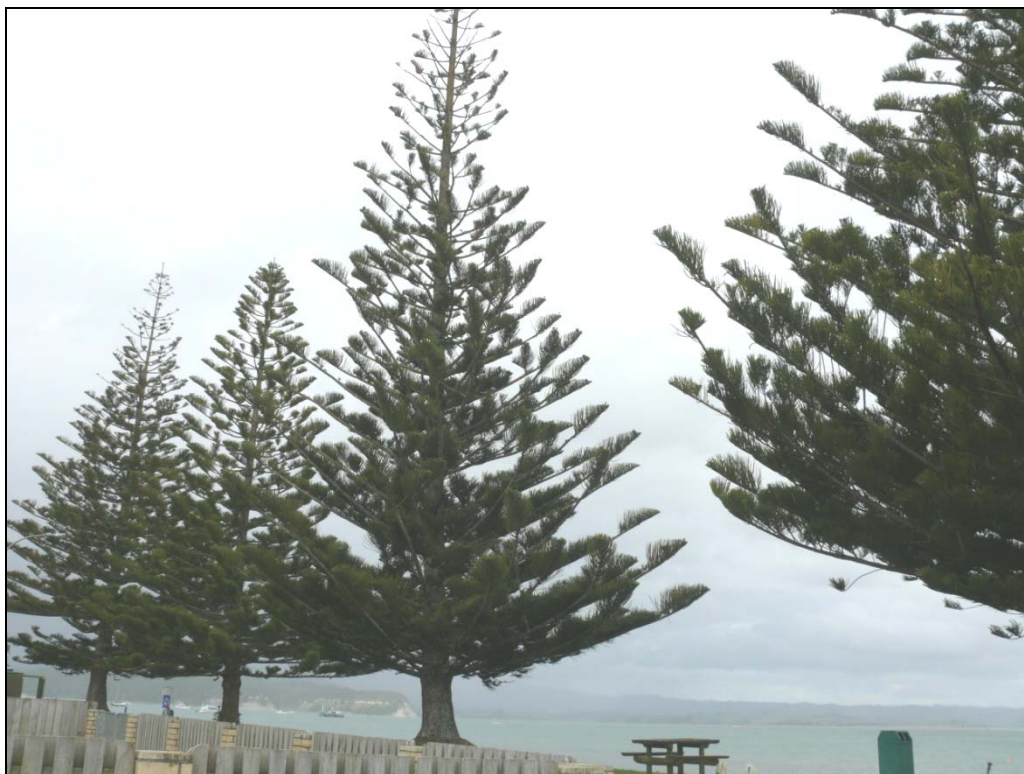
This group of Norfolk Island pine trees is unusual in that several of the trees are looking rather poorly – uneven growth, defoliated branches, resin flux. This species is generally very healthy and tolerant of harsh coastal conditions.

Figure 80 disfigured tips in two trees.

Better protection from the sea, re-build the broken sea wall.
