TE KAUNIHERA Ā-ROHE O
ŌTOROHANGA
DISTRICT COUNCIL

ŌTOROHANGA COMMUNITY BOARD

Information only reports	Ngā pūrongo mōhiohio anake
Item 37 Ōtorohanga Girl Guide Hall maintenance update to July 2025	18

4 December 2019

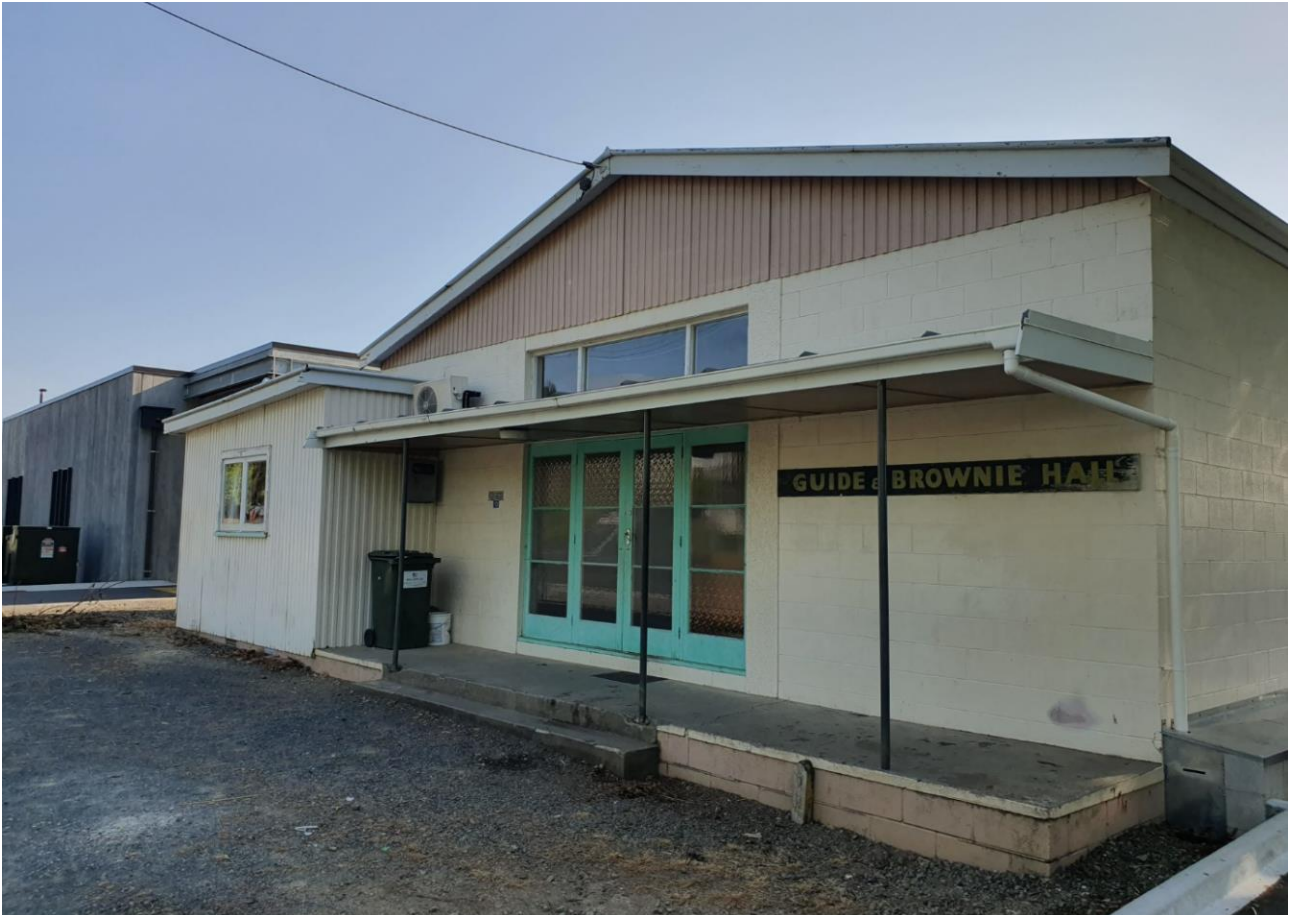
Figure 1: External photo

The Otorohanga Girl Guide Hall was constructed in 1968 by Crombie and Barlow. The design engineer was John Norton.

The total floor area is 197m², consisting of the Hall at 146 m², the Annex at 41m² and the entry porch, at 10m².

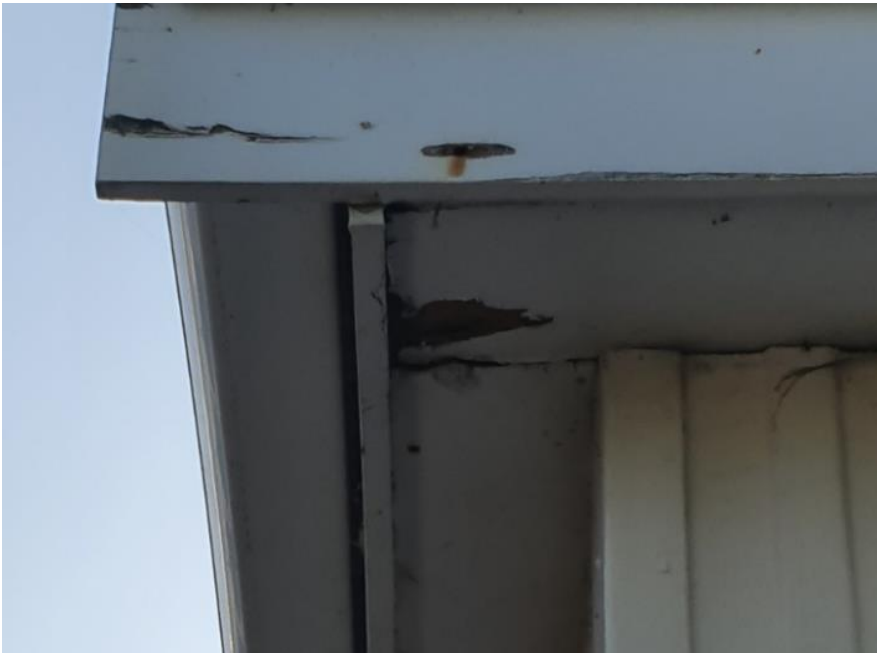
Figure 2: Example of rotting exterior timbers

Rotting exterior timbers

The timber fascia and barge are starting to rot at the ends, and the narrow timber eaves to the main hall are rotting in some areas. Rotten timbers should be removed and replaced. Undamaged timbers with cracked and peeling paint should be sanded back and repainted.

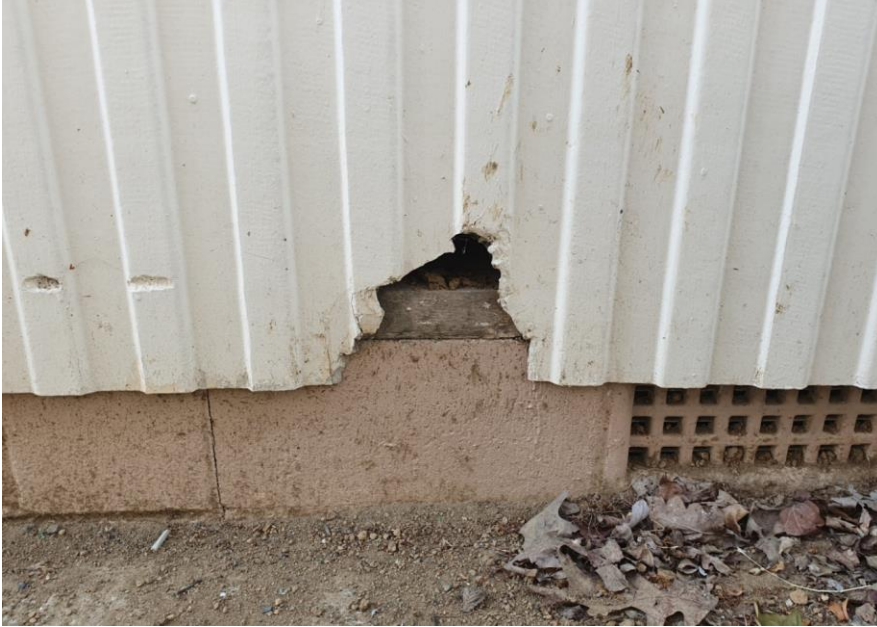
Figure 3: Example of damaged ACM cladding

Damaged asbestos cladding

A number of damaged ACM panels were identified. At minimum the damaged areas should be encapsulated (by painting) to prevent asbestos fibres escaping.

We are confident that the fibro cement external cladding used on this building is an Asbestos Containing Material (ACM). Some of the cladding has been damaged and may become friable if not repaired. ACM can be made safe with appropriate encapsulation (regular painting).

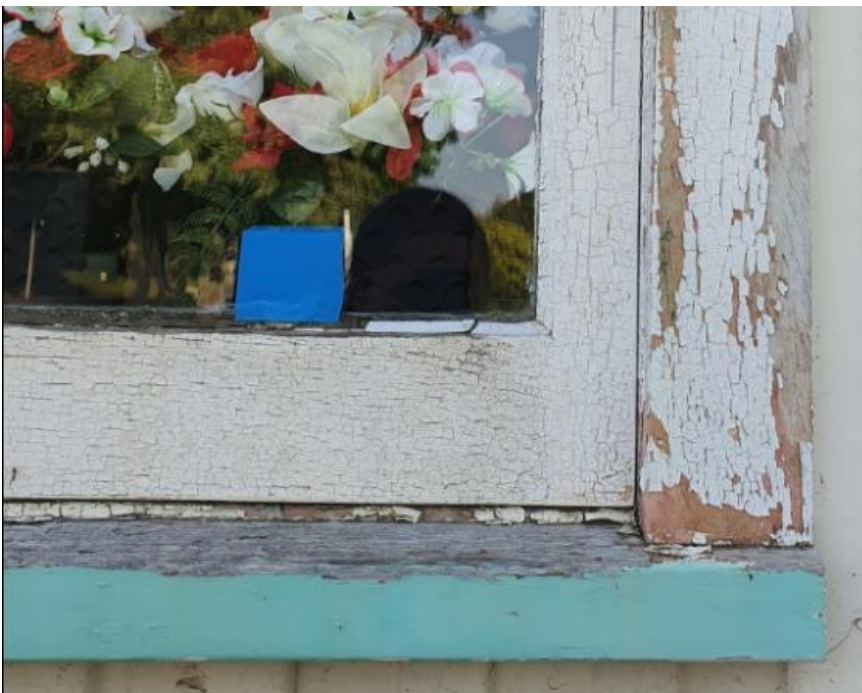
Figure 4: Example of window paint

Poor quality paint to doors and windows

The paint to the windows and doors is in very poor condition. The doors and windows require painting with some urgency to prevent further degradation.

The windows and glazed doors are all timber single-glazed. The doors do not appear to be glazed with safety glass. The paint to the windows is in very poor condition - if the windows are to be retained they will need to be stripped back and painted with some urgency.

Given the poor thermal efficiency of the existing joinery, we recommend complete replacement.

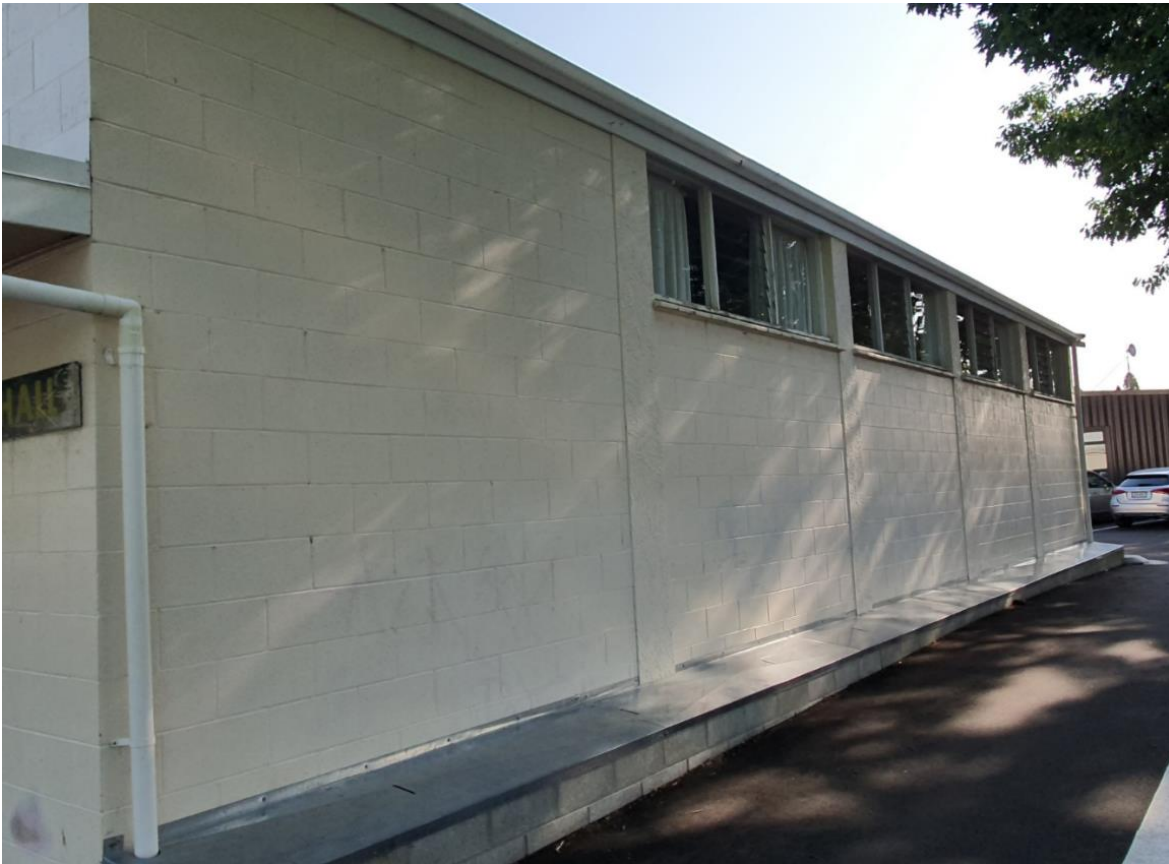
Figure 5: 'Duct' feature

Landscaping around the building has been built up to a point where surface water around the building has nowhere to run off. The new driveway is higher than the subfloor area of the building, and the existing gravel area at the front of the building has been built up so that it partially covers the subfloor vents. Because of this it is likely that the subfloor area is excessively damp and will be accelerating the decay of the building, and affecting the health of the occupants.

The building has an unusual duct like feature on the driveway side - our understanding is that this forms part of the subfloor ventilation system. It is likely that a low retaining wall was built alongside the building to allow ventilation through the strip foundations of the hall. We note that a galvanised sheet metal cover has been installed over the 'duct' - there appears to be very little allowance for ventilation in this cover, and that this lack of airflow will be worsening the moisture issues in the subfloor space.

We recommend a subfloor inspection to check the quality of the timber structure. Sources of moisture should be eliminated (may require changes to landscaping and/or additional drainage).
